**LAKE KANAWAUKE DAM**  
ROCKLAND COUNTY, NEW YORK

NY 58  
**PHASE I INSPECTION REPORT**  
**NATIONAL DAM SAFETY PROGRAM**

Prepared by  
JOSEPH S. WARD & ASSOCIATES  
CONSULTING ENGINEERS  
91 ROSELAND AVENUE, P.O. BOX 91  
CALDWELL, NEW JERSEY 07006

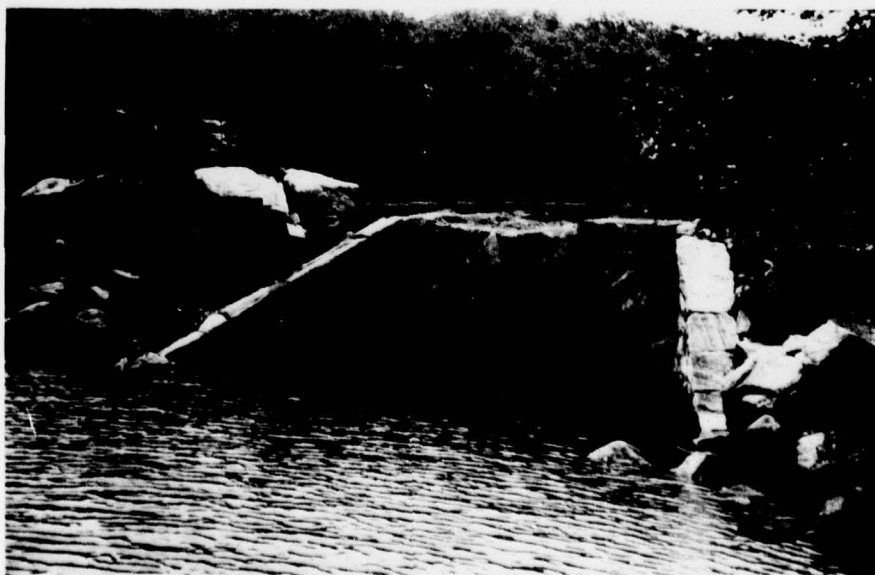
FIGURE 2 CONNECTING TUNNEL BETWEEN NORTHERN AND SOUTHERN PORTIONS OF LAKE KANAWAUKE

The northern portion of Lake Kanawauke and Little Long Pond are connected to the southern portion of Lake Kanawauke via an ungated semi-circular, stone-faced culvert, approximately 15 feet in diameter (refer to Fig. 2, Appendix D) that runs beneath State Route 210. The invert of the culvert was about 1 foot below the water surface on the day of the inspection. The northern portion of Lake Kanawauke is joined to Little Long Pond via a similar culvert approximately ¼-mile farther west on State Route 210.

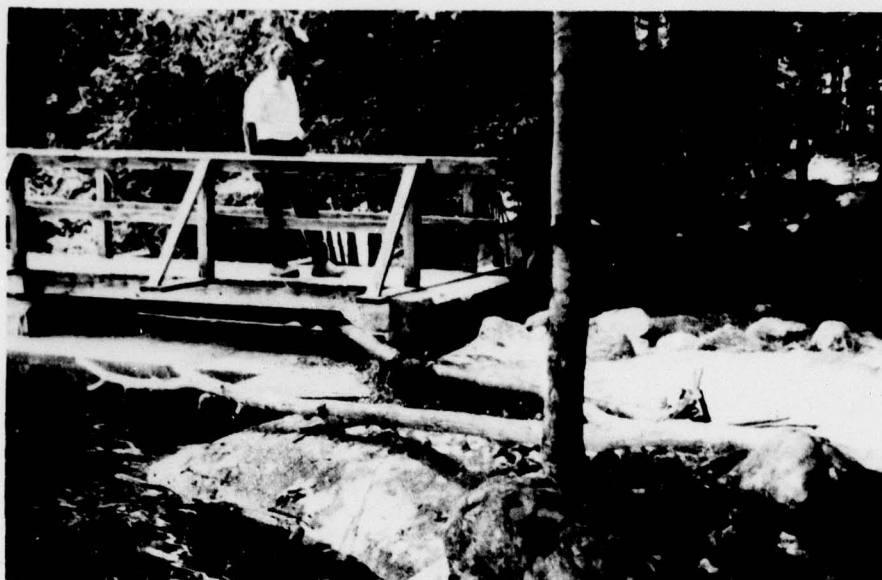
FIGURE 5 RIGHT ABUTMENT (UPSTREAM)

1) The abutments of the dam are part of the end concrete monoliths. The right abutment rests on a rock outcrop (Fig. 5, Appendix D) but it was not possible to determine if the abutment is anchored to the rock. There are no rock outcrops at the left abutment (Fig. 6, Appendix D). However, the existence of such outcrops nearby suggests that rock may be within several feet of the surface, and the design drawings indicate that the left abutment also rests on rock.

iii. would probably not be able to pass the SDF (in this case the PMF) without obstruction by the wooden walkway and breaching around the abutments. Water surface elevation is approximately 830.45 at the SDF, and although the top of the abutments is at elevation 830.75, the shoreline adjacent to the abutments is lower (see Fig. 5, Appendix D).
